Riparian & Wetland Habitat Assessment

Middle Boulder Creek
Town of Nederland
Boulder County, Colorado

Western Ecological Resource, Inc.
711 Walnut Street, Boulder, CO 80302

March 2016

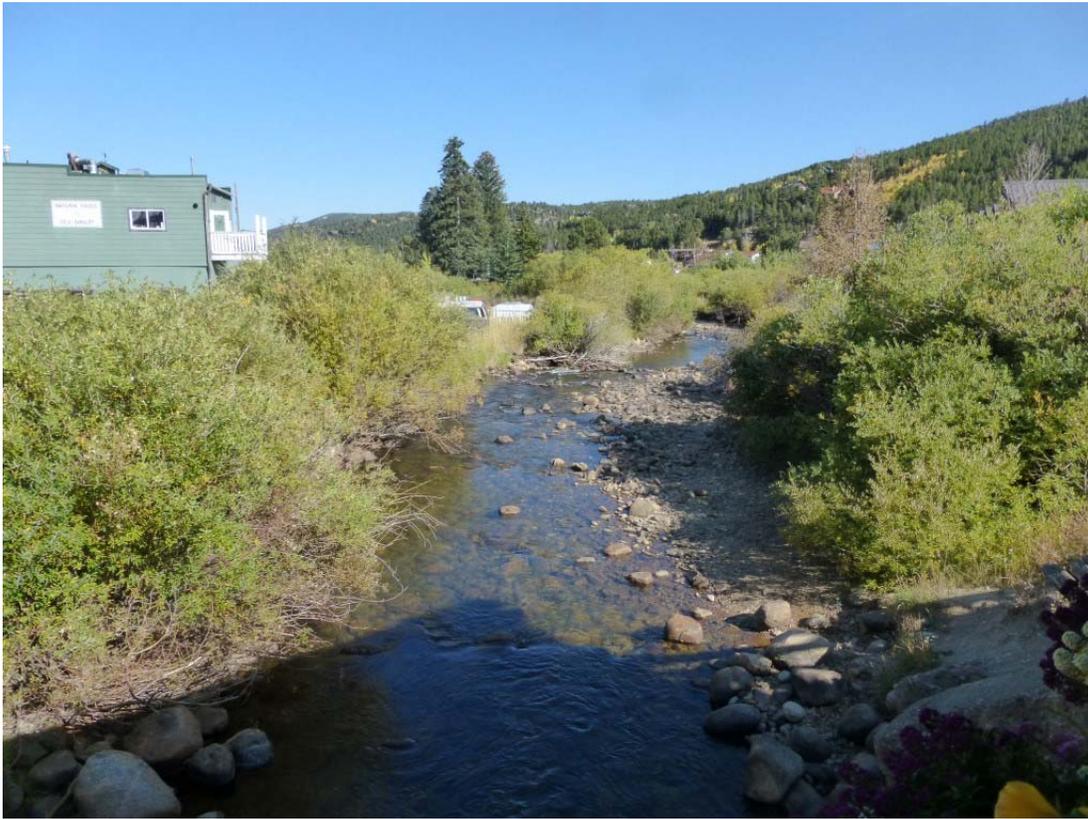
The riparian and wetland habitat along Middle Boulder Creek (Photo 1) is generally dominated by willows with occasional shrubs of alder (*Alnus incana* subsp. *tenuifolia*) and river birch (*Betula fontinalis*). Stands of aspen trees (*Populus tremuloides*) occur in the eastern portion of the project area. The riparian understory is variable depending on hydrologic regime and degree of shading. Common understory plants in the riparian-wetland areas include fowl bluegrass (*Poa palustris*), bluejoint reedgrass (*Calamagrostis canadensis*), water sedge (*Carex utriculata*), beaked sedge (*Carex utriculata*), and smallfruit bulrush (*Scirpus microcarpus*). In drier upland riparian areas, plants such as bush honeysuckle (*Distegia involucrata*), Woods' rose (*Rosa woodsii*), starry false Solomon's seal (*Maianthemum stellatum*), cow parsnip (*Heracleum sphondylium*), field horsetail (*Equisetum arvense*), and fireweed (*Epilobium angustifolium*) occur.

Photo 1. Middle Boulder Creek, looking downstream from the covered bridge.

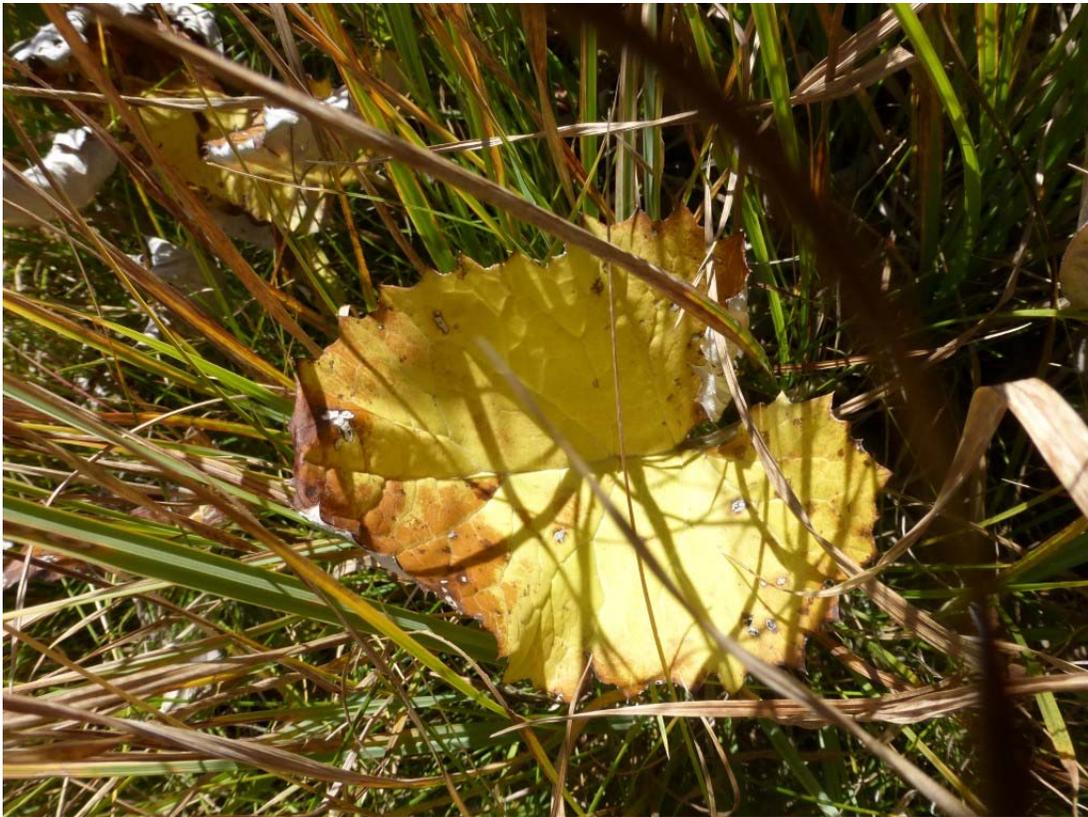
One high-quality wetland area was observed just northeast of the Magnusson Hotel. This wetland is dominated by wetland graminoids including water sedge, bluejoint reedgrass and Baltic rush (*Juncus balticus*). The landform of this area suggests that it may support deep organic-rich soils, or peat, indicating it could be a fen. However, no fen assessment has been completed to date. In addition, this wetland has a small population of sweet coltsfoot (*Petasites frigidus* var. *sagittatus*), an uncommon wetland plant in Colorado (Ackerfield 2015). See Photo 2. This plant carries no legal protections, *per se*, however it is considered a Species of Local Concern by the U.S. Forest Service and the presence of sweet coltsfoot can indicate specialized wetlands that harbor other rare plants (Popovich 2015). A description of the plant follows.

Photo 2. Sweet coltsfoot. An uncommon plant found in the wetland northeast of the Magnuson Hotel.

One high quality wetland area was identified just northeast of the Magnusson Hotel. A formal pedestrian trail currently bisects this wetland area. If desired, the trail could be removed and the area restored back to wetland. This would enhance both the hydrologic connectivity of the wetland with Middle Boulder Creek and the wildlife habitat connectivity.

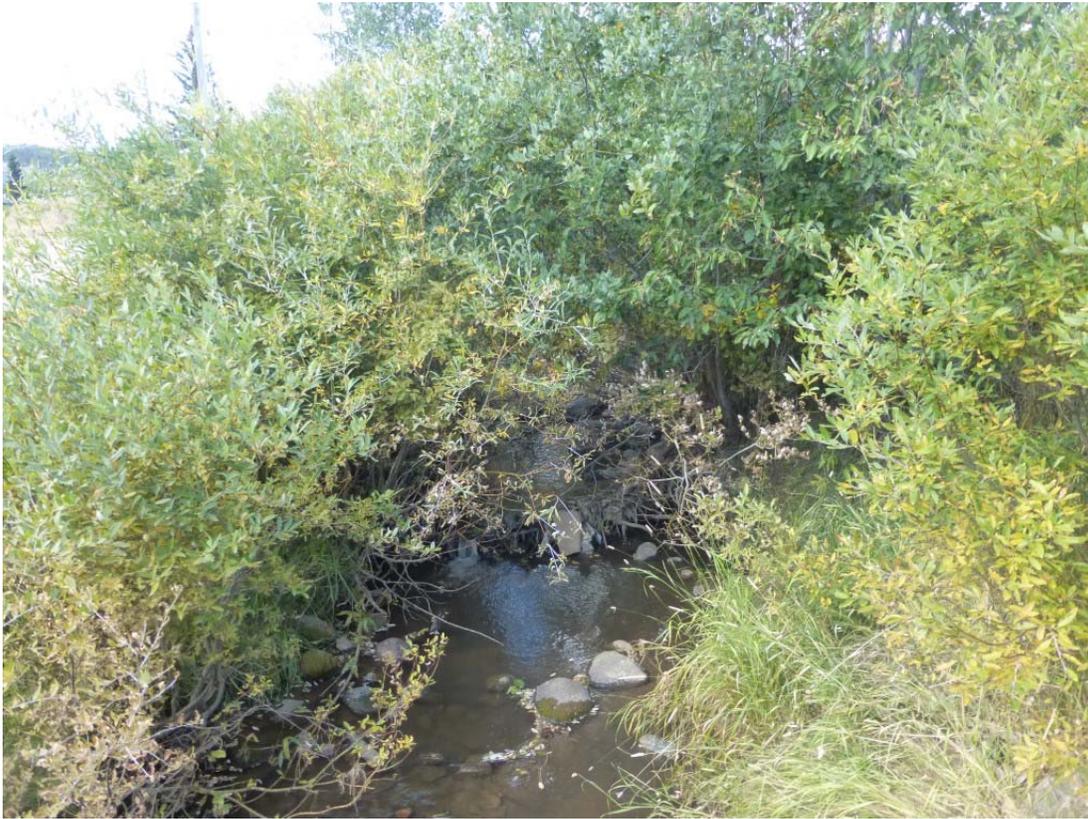
North Beaver Creek is a small perennial stream, approximately 2 feet wide. The headwaters of North Beaver Creek are located in the Caribou Valley west of the Town of Nederland. Like Middle Boulder Creek, the riparian habitat along North Beaver Creek is comprised of willows with the occasional alder and river birch. In the understory, cow parsnip, redtop, Wood's rose, and starry false Solomon's seal are common. Canada thistle, a noxious weed, is quite common along portions of this stream. See Photo 3.

Photo 3. North Beaver Creek.

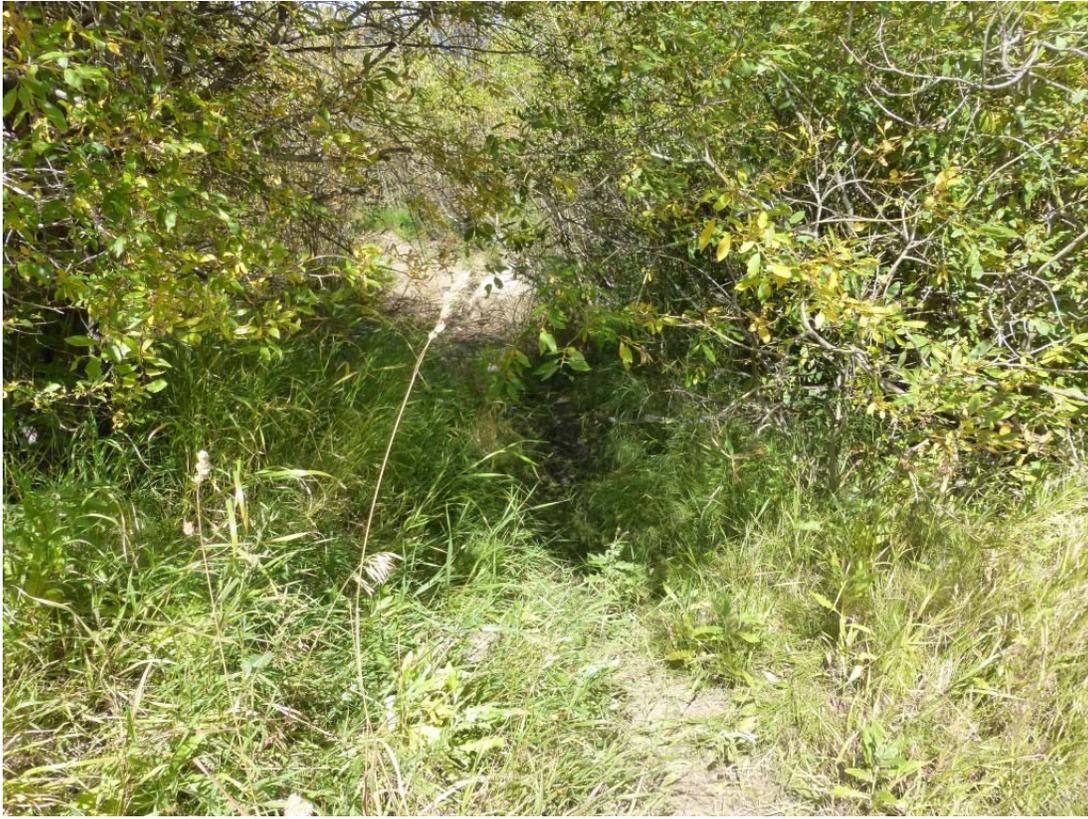
The riparian and wetland habitats of the project area receive significant human use and numerous social trails were observed throughout the area (See Photo 4). The majority of these trails should be eliminated in order to preserve the ecological integrity of the area. Trails fragment habitat leading to increased human use and wildlife disturbance and are corridors for weed invasion. In addition, frequent trail use leads to soil compaction, trampling of vegetation, and lowered plant growth and reproduction. Trampling along the banks of Middle Boulder Creek was especially severe near the inlet to Barker Reservoir, just upstream of the bridge weir, where all vegetation had been eliminated and the stream banks showed evidence of erosion (See Photo 5). In addition, several trails appear to be frequented by people who leave trash and other debris, further threatening the environment. In order to eliminate social trails, signage should be posted in prime locations to dissuade people from utilizing these access points. Low-impact fencing (e.g. post and rail fencing) could also be erected across some of the social trails to prevent human use. If additional trails are needed within the project area, then the location of these trails should be closely analyzed in order to maximize public benefit while reducing environmental impacts. Finally, the old chain-link fence and trash should be removed from North Boulder Creek just upstream of where it enters Middle Boulder Creek.

Photo 4. Example of one of the many social trails in the riparian habitat.

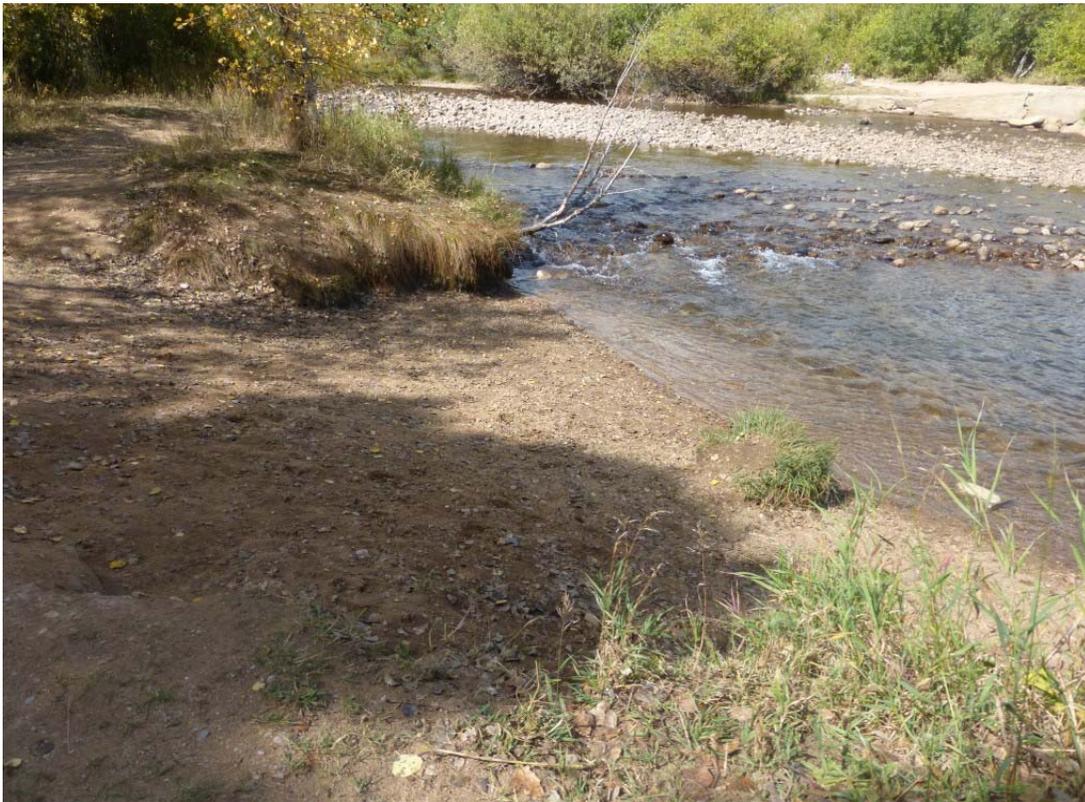
Photo 5. Social use of this area along Middle Boulder Creek just upstream of the weir bridge has eliminated most riparian vegetation.

Plant native willows and/or other shrubs along North Beaver Creek and Middle Boulder Creek in the areas identified in Figure 3. Native shrubs can either be purchased through native plant nurseries (min. 5-gallon size recommended) and planted similarly to landscape shrubs, or, for a more economical approach, we recommend sprigging willows from adjacent stands in early spring prior to leaf-out. Willows have adventitious buds and will root out if a cutting is placed in the appropriate habitat. The use of volunteers or local youth from Teens Inc. would further reduce costs. In addition, encourage private land owners abutting the creek to plant native trees and shrubs to enhance the structural and species diversity of the riparian habitat. Table 2 contains a list of native shrubs and trees appropriate for Nederland. See Photo 5.

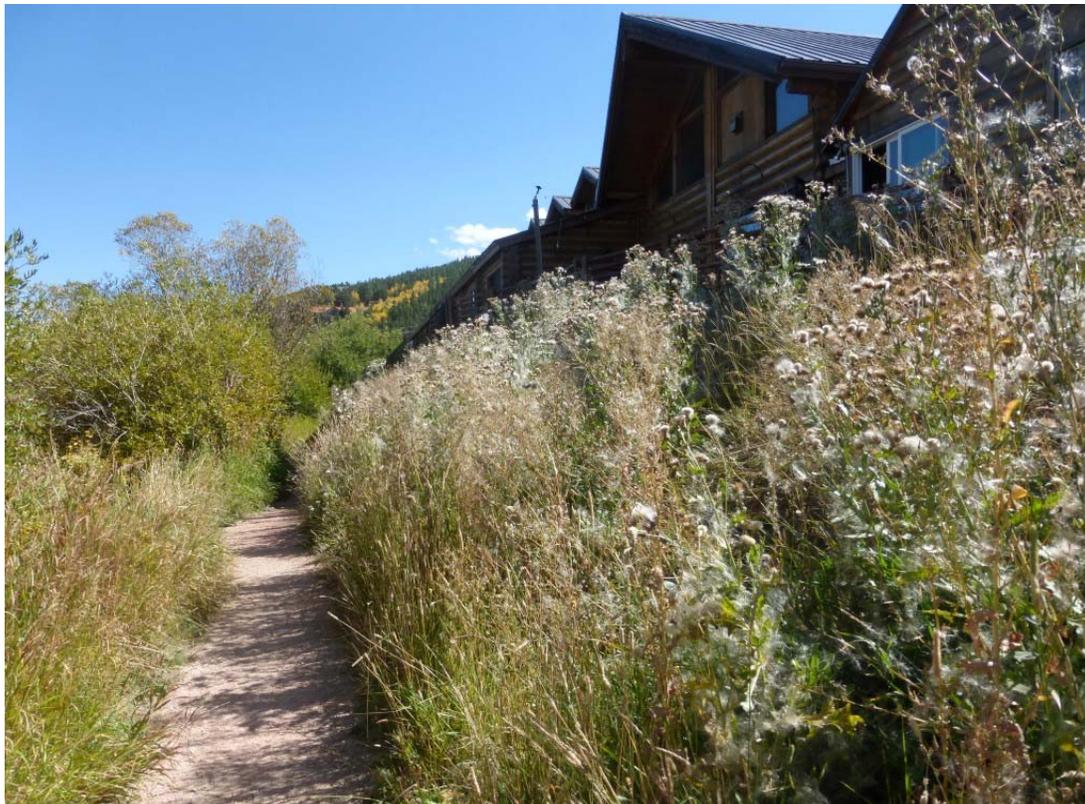
Noxious weeds are extremely problematic in and around the project site as well as within the Town of Nederland. Noxious weeds decrease species diversity and the ecological integrity of habitats including riparian areas. In addition, weeds will continue to spread outside of the project site, and become established at local trailheads and elsewhere on National Forest Systems lands. We highly recommend that the Town implement an Integrated Weed Management Plan for the project area. Specific Colorado state-listed noxious weeds observed within and adjacent to the riparian and wetland habitats include Canada thistle, ox-eye daisy, and scentless chamomile. See Photo 6.

Photo 6. Dense stands of Canada thistle, a noxious weed, along the path behind the Magnuson Hotel.

- Survey project areas to document the presence of any pre-existing weed infestations. Treat infestations prior to ground-disturbing activities and remove all weed seed and propagules to prevent weed spread.

- Locate and use weed-free project staging areas. Where this is not possible, treat existing noxious weeds in these areas prior to the staging of any equipment.

- To minimize risk of noxious weed introduction and spread, require that all equipment used for ground-disturbing activities be clean, i.e., free of mud, dirt, plant parts, and seeds, or other debris that could contain or hold plant parts or seeds, prior to entering the project area, and prior to leaving a weed-infested project area.

- Use certified weed-free hay, straw or mulch. However, preference should be given to use of non-agricultural mulch products such as wood straw or bonded fiber matrix.

- Monitor revegetated areas for noxious weed invasion and treat infestations.

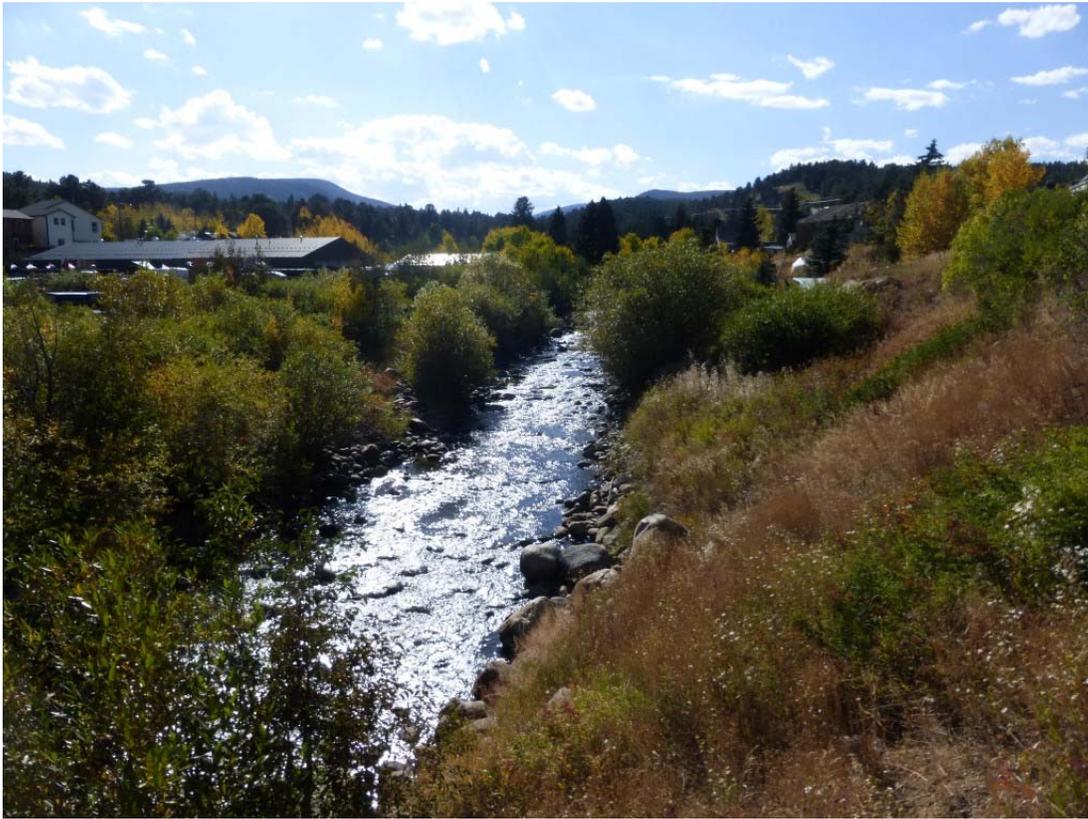
Photo 7. Narrow bank of riparian vegetation on the north side of Middle Boulder Creek on the bank parcel.

- North side of Middle Boulder Creek on the bank parcel. The slope below the Visitor's Center parking lot is extremely steep and limits the development of wetland and riparian habitat in this area. If the landform in this area cannot be changed due to excessive cost, additional plantings of willows or other riparian shrubs could occur on the bank in order to provide a continuous band of scrub-shrub habitat. See Photo 7.

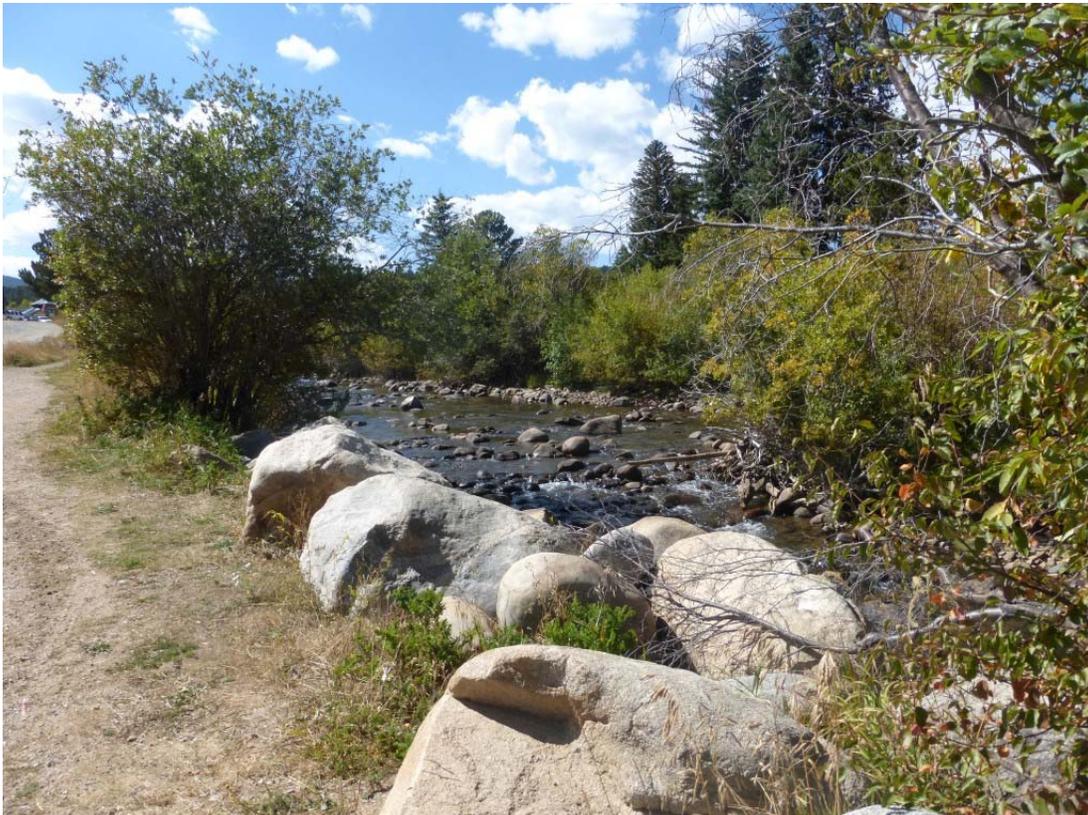
Photo 8. Lack of riparian habitat along the Chipeta Park parking lot.

- South side of Middle Boulder Creek adjacent to the Chipeta Park parking lot. The riparian habitat along the Chipeta Park parking area is extremely narrow and has been replaced by large boulders. The parking lot could be reconfigured to allow the same amount of parking with a smaller footprint. This would allow the riparian habitat to be widened along the south bank of the creek. (Photo 8).

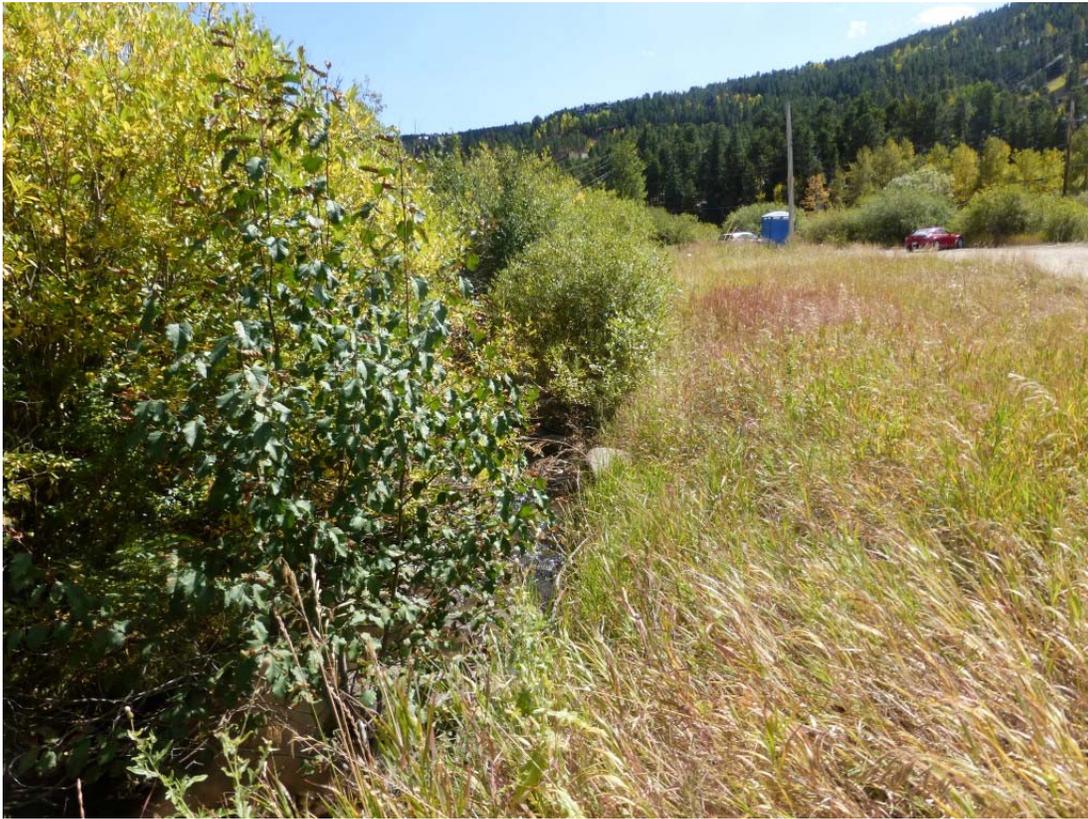
Photo 9. Elevated fill along North Beaver Creek at Fisherman’s parking lot.

- Fisherman's Parking Lot. There are two areas at Fisherman's parking lot that are constricting the riparian habitat development along Middle Boulder Creek and North Beaver Creek. The fill could be removed in these areas to restore the floodplain and additional riparian shrubs could be planted to restore the riparian habitat. (Photos 9 and 10).

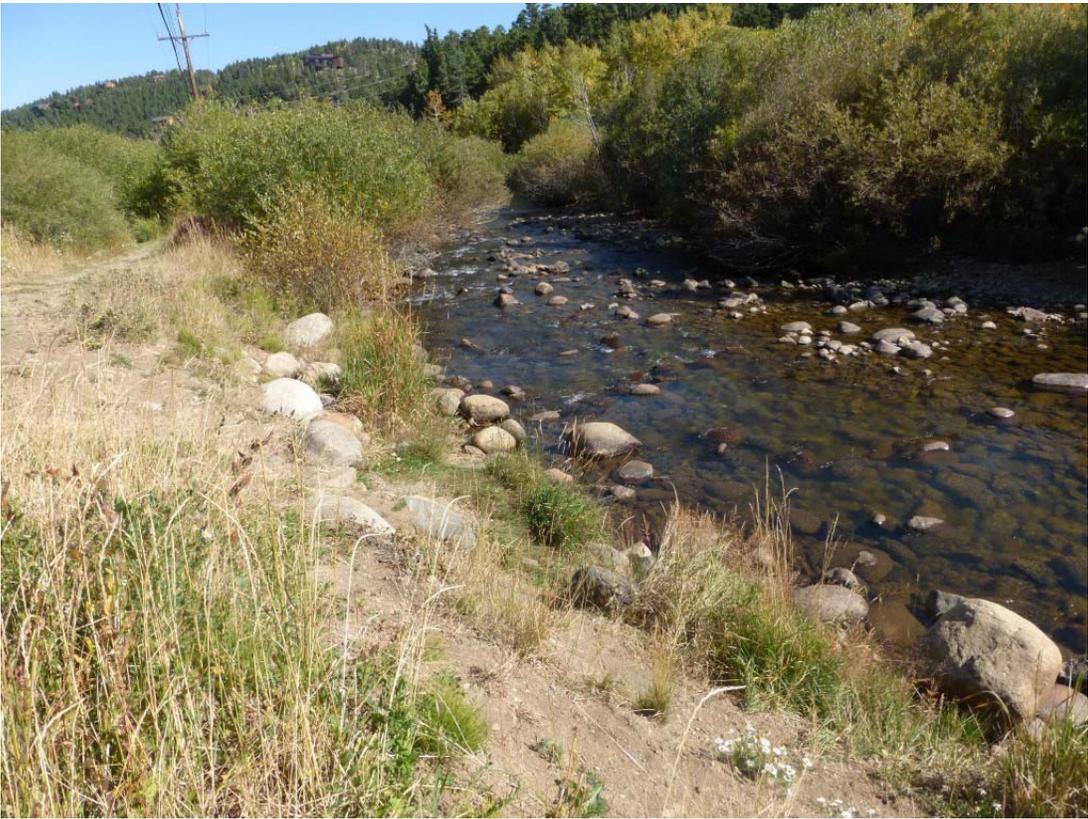
Photo 10. Elevated fill along Middle Boulder Creek at Fisherman’s parking lot.

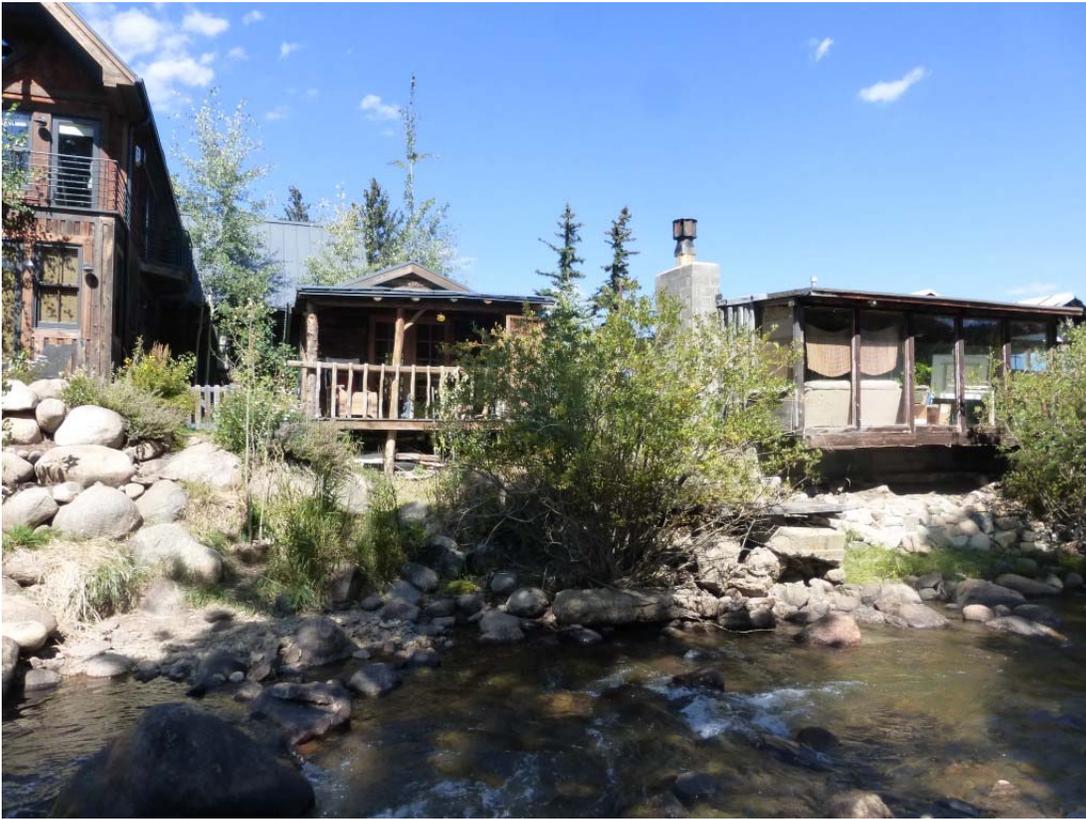
stream banks show extremely heavy human use. At least one home abutting the creek appears to have inadequate backfill materials along its foundation able to withstand the erosive forces of the creek when it is running at or above bankfull. Finally, the creek has an accumulation of gravel deposits and appears to be over-widened near its entrance into Barker Reservoir. However, this may simply be the result of a change in channel slope, the configuration of the weir bridge, or other factors which cause the water to slow and gravels to deposit.

Photo 11. Bank instability along homes on north side of Middle Boulder Creek.

One or more homes along Middle Boulder Creek appear to have suffered the erosive forces of the creek in the recent past. The bank of the creek may need to be stabilized with larger materials so that the structural integrity of the building foundations is maintained. If possible, add larger

diameter willow stakes along with large cobble material to enhance the shrubby riparian habitat in this area. See Photo 11.

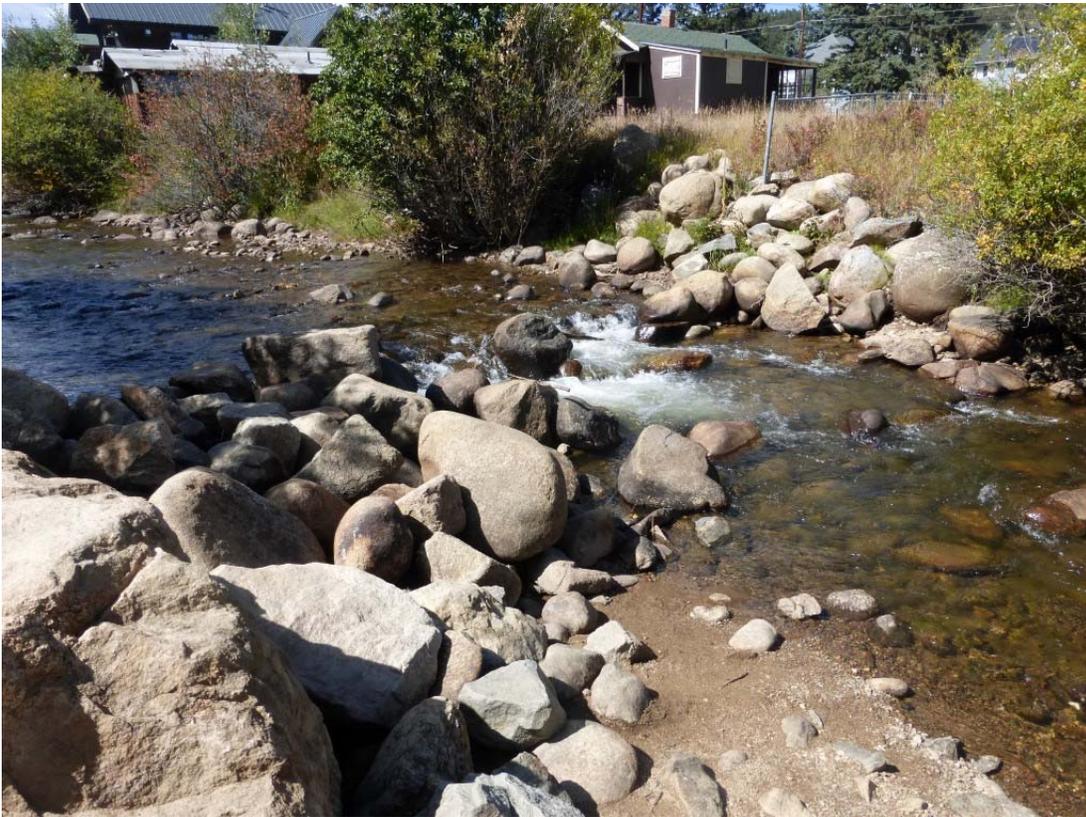
Photo 12. Rock check dam below homes pictured in Photo 11.

One instream rock structure is located in Middle Boulder Creek, just downstream of the homes identified in Section 6.3.2 above. This rock drop structure should be analyzed by a fluvial geomorphologist or a stream hydrologist to determine its effectiveness and its affect (if any) on the bank erosion adjacent to the upstream homes. See Photo 12.
